SAFEHOUSE

LNG PLANT LIFE EXTENSION HABITATS

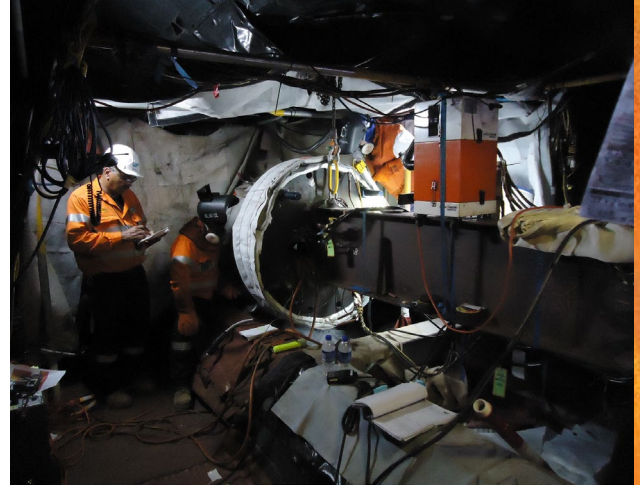
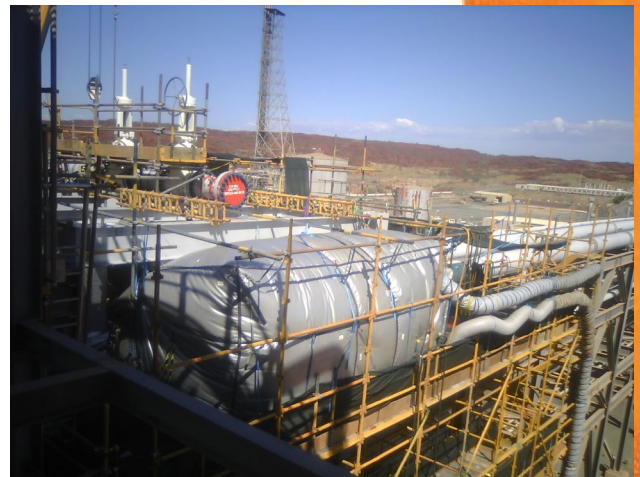
The effective use of our IECEx air conditioning units in conjunction with our insulated habitat system ensured that a safe work environment was provided.

Despite the searing heat, our habitat system delivered a safe and comfortable working environment, and the work scope was completed on schedule without incident. We went on to install and monitor another 20 habitats for the duration of the life extension project, creating safety and delivering productivity.
